ADVISORY CIRCULAR 43-16A

AVIATION MAINTENANCE ALERTS

**ALERT
NUMBER
283**

**FEBRUARY
2002**

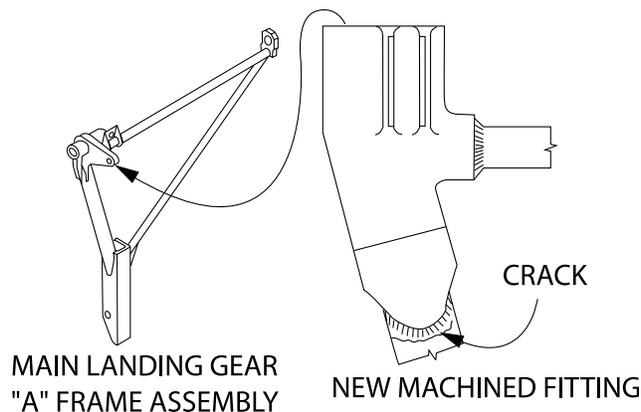
While conducting an annual inspection, the inspector discovered the right main landing gear "A-frame" was cracked.

The crack traveled approximately half way around the "A-frame" tube circumference, and the assembly was in imminent danger of complete failure. The defect was in the same location discussed in Airworthiness Directive (AD) 97-06-10. This AD requires recurring inspections in this area until the original "A-frame" is replaced with the newly-designed assembly. (Refer to the illustration.) In accordance with this AD and Raytheon Service Bulletin 2361, the original "A-frame" had been replaced with a newly-designed "A-frame" assembly (P/N 105-810023-76). In this case, it was the newly-designed "A-frame" assembly that failed.

The submitter urged all technicians to inspect this area closely during scheduled inspections and maintenance.

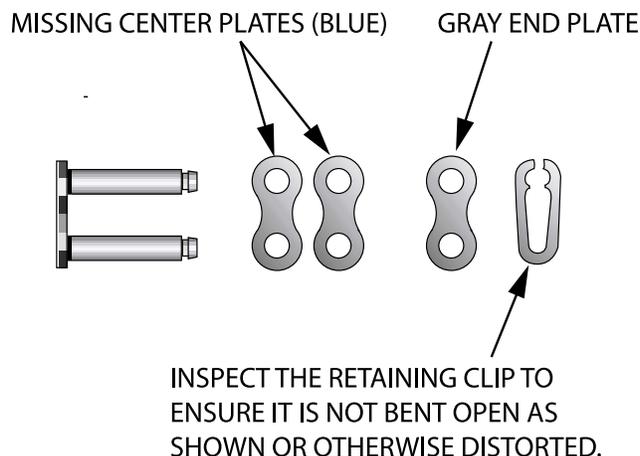
While complying with a 6-year inspection and maintenance requirement, the technician replaced the nose landing gear retraction duplex chain. An inspector discovered the duplex chain-connecting link (P/N 131378-25-2CL) was not installed correctly.

The inspector discovered the duplex chain connecting link center plates were missing. When the technician was asked about this problem, he stated the center plates were not furnished with the other parts. (Refer to the illustration.) After investigating further, the inspector contacted Beech, and discovered Beech had been experiencing "vendor problems" related to the duplex chain-connecting link. They contacted a number of parts suppliers and discovered that several "parts bags" were on the shelf and contained only three items instead of the required five.

The submitter stated, "The maintenance manual is not specific enough to inform a technician on how many pieces should be inserted into the assembly." At the time of this writing, it is unclear if this problem has been resolved. However, all maintenance personnel should take note of these circumstances and ensure proper installation of the nose gear duplex chain-connecting link assembly.

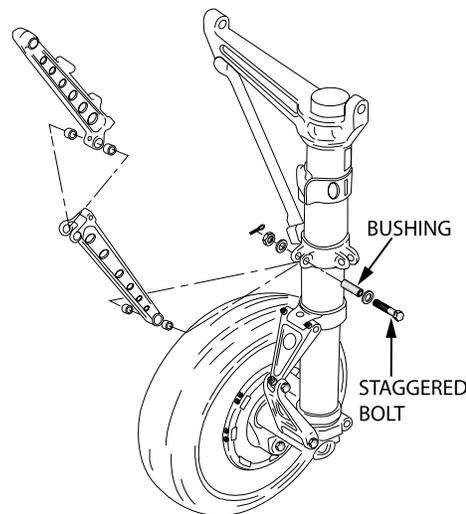
During a scheduled inspection, the technician discovered the right main landing gear drag-link bolt was defective.

The defective bolt (P/N NAS464P6-28/M) was installed at the lower end of the drag brace where it attaches to the main gear trunnion. (Refer to the illustration.) The drag link assembly was very stiff and the movement was restricted. The technician tried to remove the lower bolt and discovered it was very difficult to remove. Once the bolt was out, he noticed the bolt shank was "staggered" by approximately .020 inch. This finding indicates the bolt was subjected to excessively high shear loads.

The technician reviewed the aircraft maintenance records. The records indicated the drag link joints were disassembled, to replace the bushing, 561 operating hours prior to this finding. At that time, the bolt was in serviceable condition. He recommended placing the aircraft on jacks every 200 hours of operation and inspecting the drag brace joint components for condition and serviceability. Also, the defective bolt has been superseded by another bolt (P/N 130909B130).

Technicians should check the current parts manual when installing replacement parts.

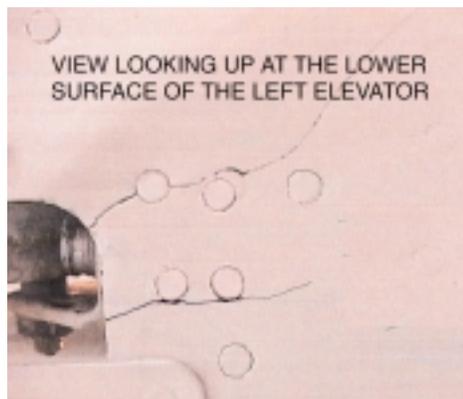
During a scheduled inspection, the inspector discovered two cracks on the elevator.

The left elevator lower skin (P/N 50-610000-432) was cracked at the outboard hinge point cutout. One skin crack traveled from the hinge cutout aft, through two rivet holes, and extended across the spar cap for a total distance of approximately 3 inches. The other skin crack was approximately 1.75 inch long and traveled from the hinge cutout, across the spar cap, and through two additional rivet holes. (Refer to the illustration.)

The submitter did not give the condition of the spar cap or other structures in this area. He recommended that all personnel involved with like aircraft be aware of these findings and give this area close attention at every opportunity.

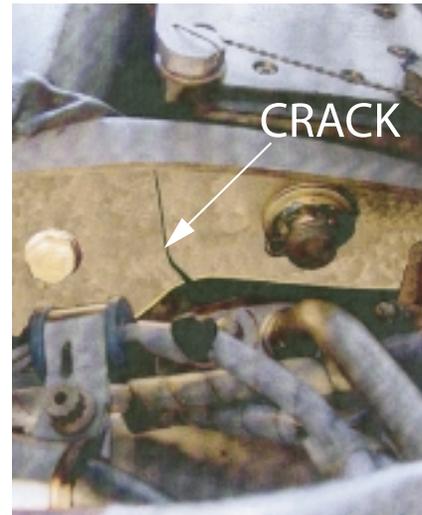
During a scheduled inspection, the inspector discovered a crack in the left engine mount assembly.

The right engine, left forward carry-through beam bracket (P/N 45A34361-5) was cracked through the web at a radius. (Refer to the illustration.) A review of the maintenance records for this operator's fleet of like aircraft revealed this was the fourth similar failure in the past 2 weeks.

The submitter gave no cause for this defect. He suggested that all operators of like aircraft check this area closely at every opportunity.

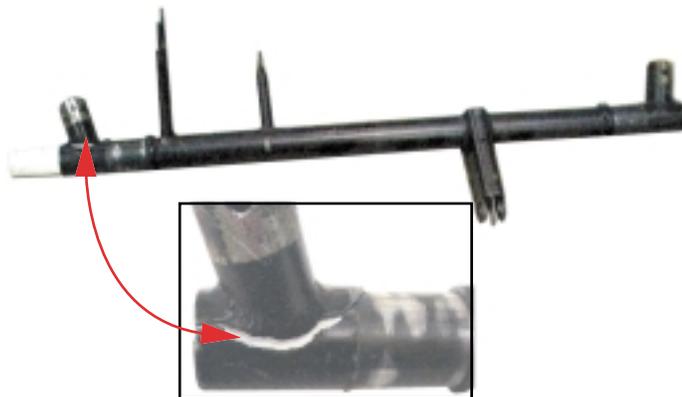
While the pilot was taxiing out for takeoff, he lost rudder control and found braking action was difficult.

A technician discovered the pilot's right rudder pedal attachment to the rudder bar assembly (P/N 0411526-1) was cracked. The crack was located at a weld and traveled around and adjacent to the weld. The attachment was in imminent danger of complete failure. (Refer to the illustration.)

The submitter recommended that technicians check this area closely during inspections and maintenance.

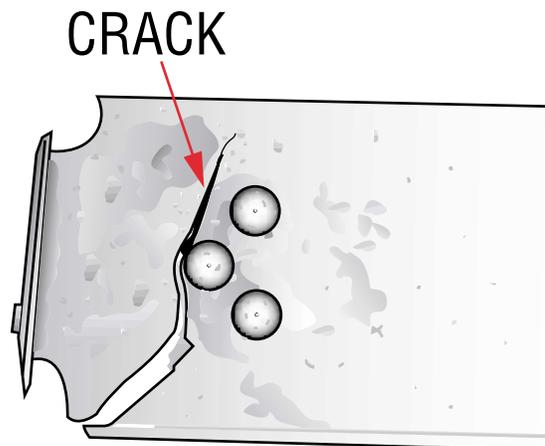
While performing other maintenance, a technician discovered structural damage on the elevator.

The technician removed the right elevator to replace a worn outboard bushing and discovered the elevator spar (P/N 0432001-21) was cracked. The spar crack was located under and adjacent to the outboard elevator hinge bracket. (Refer to the illustration.)

The submitter did not give a cause for this defect. However, the defect may have been caused by age, normal and abnormal operational vibrations, and the operational environment in which the aircraft was used. This area deserves close scrutiny during inspections and maintenance.

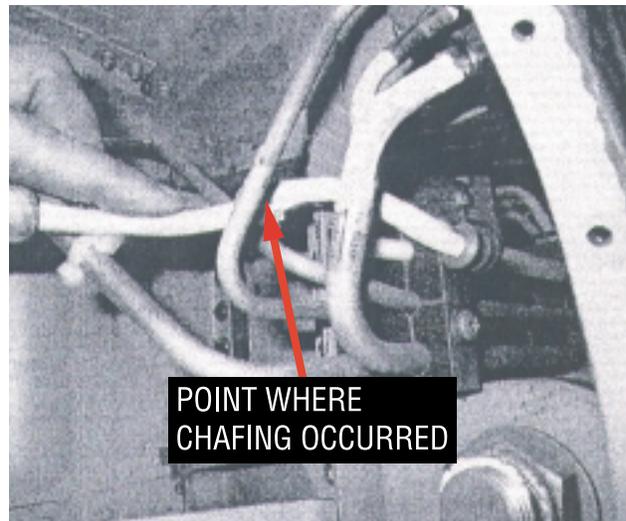
A technician discovered a wire, located inside a bundle in the left wheel well area, was shorted to ground. The wire bundle, consisting of approximately seven wires, was encased in “Shrink Wrap.” The chafing action of the wire bundle against a hydraulic line had penetrated the “Shrink Wrap” and the wire insulation causing the electrical short. (Refer to the illustration.) The technician replaced the “Shrink Wrap,” installed additional chafe protection, and repositioned the wire bundle to provide adequate clearance.

It is fortunate that the electrical arcing did not penetrate the hydraulic line and cause hydraulic system failure.

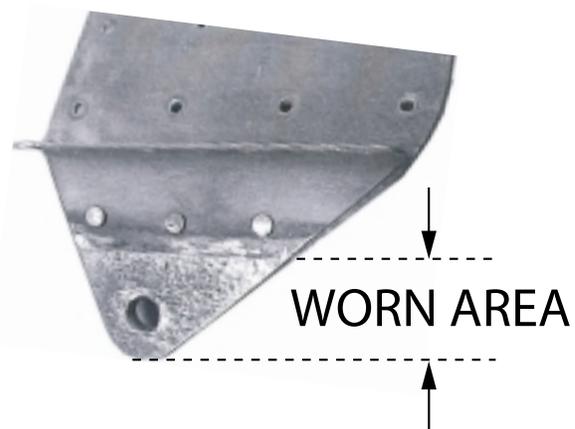
During a scheduled inspection and maintenance, a technician discovered the right wing attachment was defective.

When the technician applied hand pressure to the inboard top or bottom of the wing leading edge, it produced a corresponding movement at the forward wing spar attachment fitting (P/N 66761-01). After disassembling the wing attachment fitting, he discovered it was severely fretted, worn, and the hole for an attachment bolt was oblong. (Refer to the illustration.) The cause for this defect was not given. The damage may be related to the aircraft's high number of operating hours.

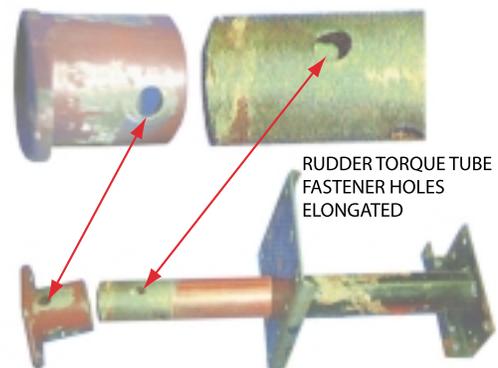
While the aircraft was in a hangar for completion of a scheduled inspection, a technician discovered the rudder torque tube was loose.

The technician investigated further and discovered the rudder torque tube (mast) attachment bolts were extremely loose. He disassembled the unit and discovered the bolt was oversized, which is allowed by the manufacturer. The fastener holes were oblong and severely worn. (Refer to the illustration.) Piper issued Service Bulletin (SB) 699 which deals with this subject and offers sound advice to correct this type of defect.

The submitter suggested that the FAA issue an Airworthiness Directive that references SB 699 and requires mandatory compliance with the SB. He stated this type of damage could easily be overlooked during scheduled inspections. He recommended that technicians be aware of these findings and give this area close attention during inspections and maintenance.
